**HUDDERSFIELD
CANAL
SOCIETY**

No. 91

TUNNEL SURVEY SPECIAL

Standedge Tunnel Condition Study

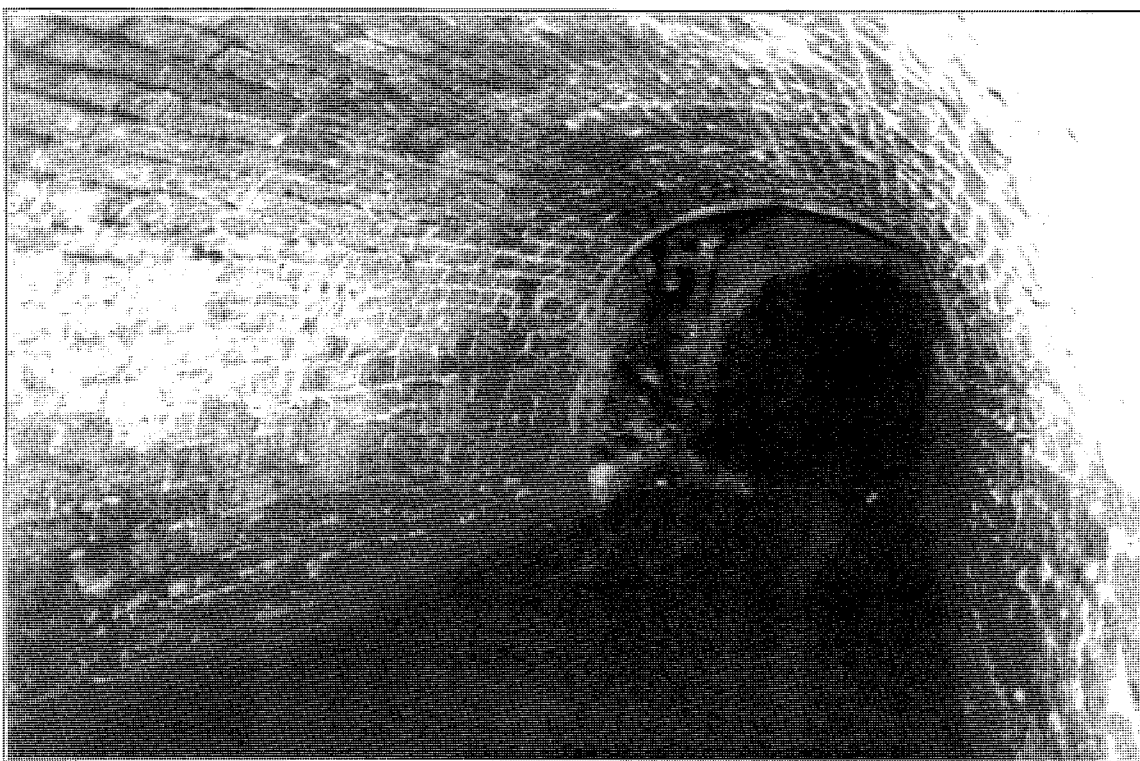
PLATE 73
Ch. 852–857 Unstable rock section. Rock debris can be seen on south-east side of canal floor.

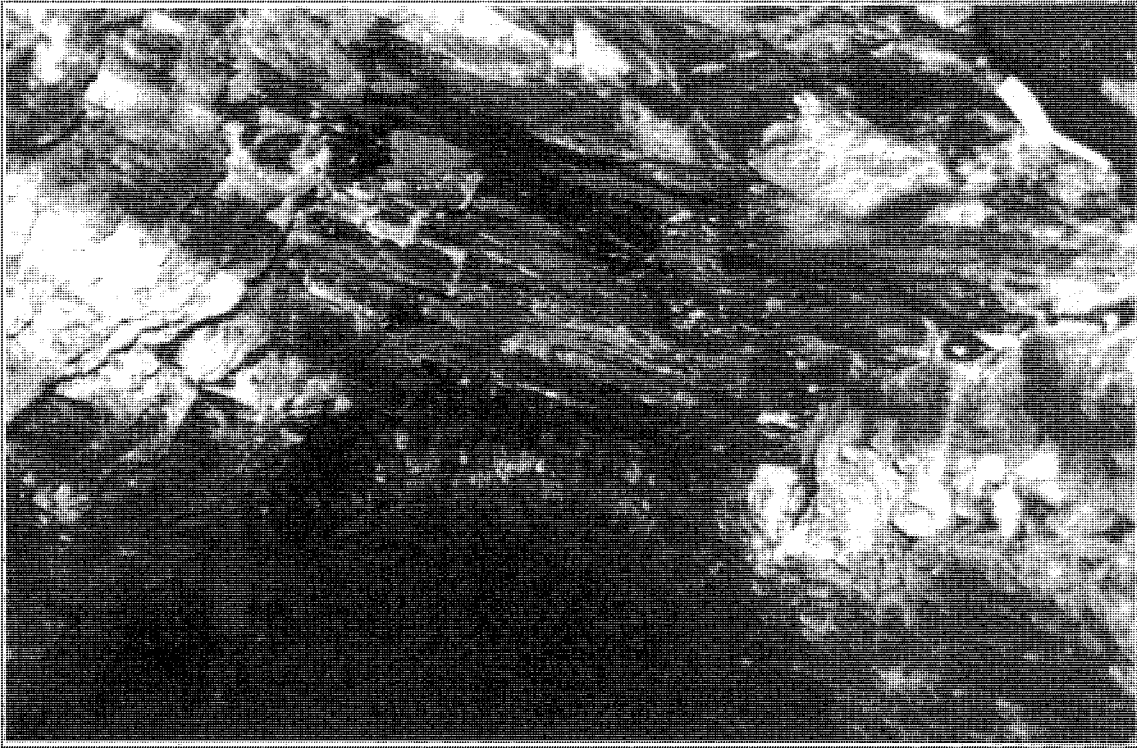
PLATE 81
Ch. 3669 – Ch. 4043 Grindlow shales.
Unstable sections will require full
lining and rock bolting with mesh and
gunite.

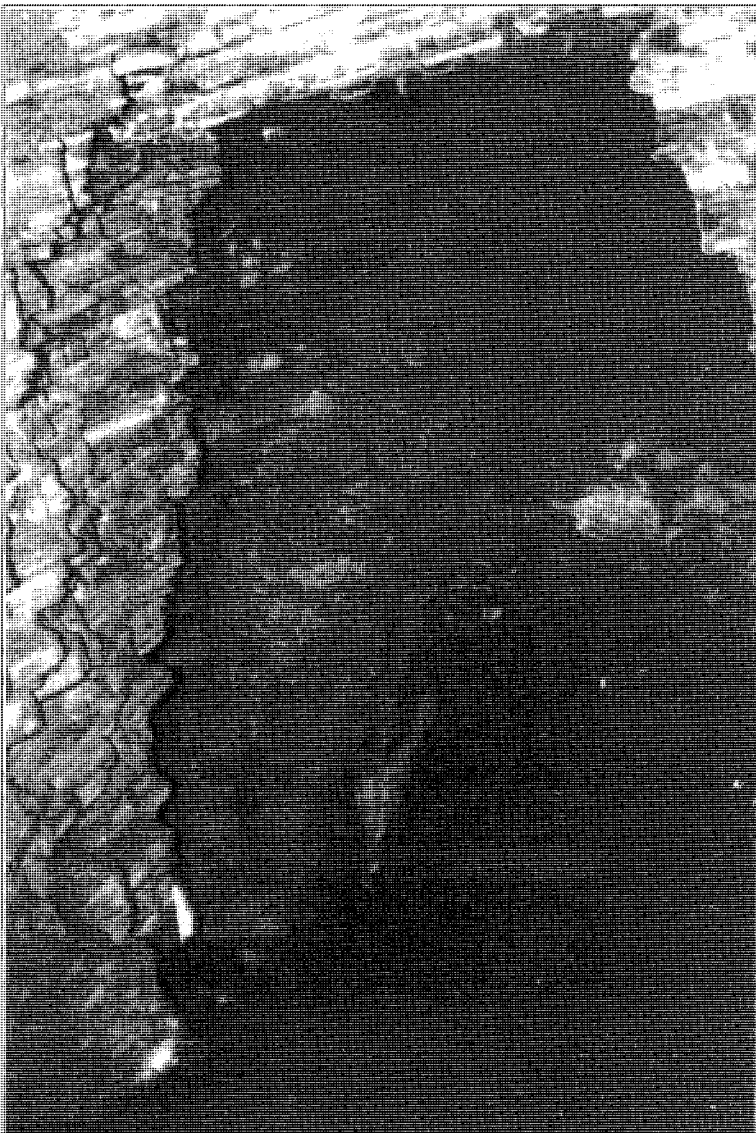
PLATE 82
Ch. 82. Tunnel intersects major fault.
Walls will require rock bolt and mesh.

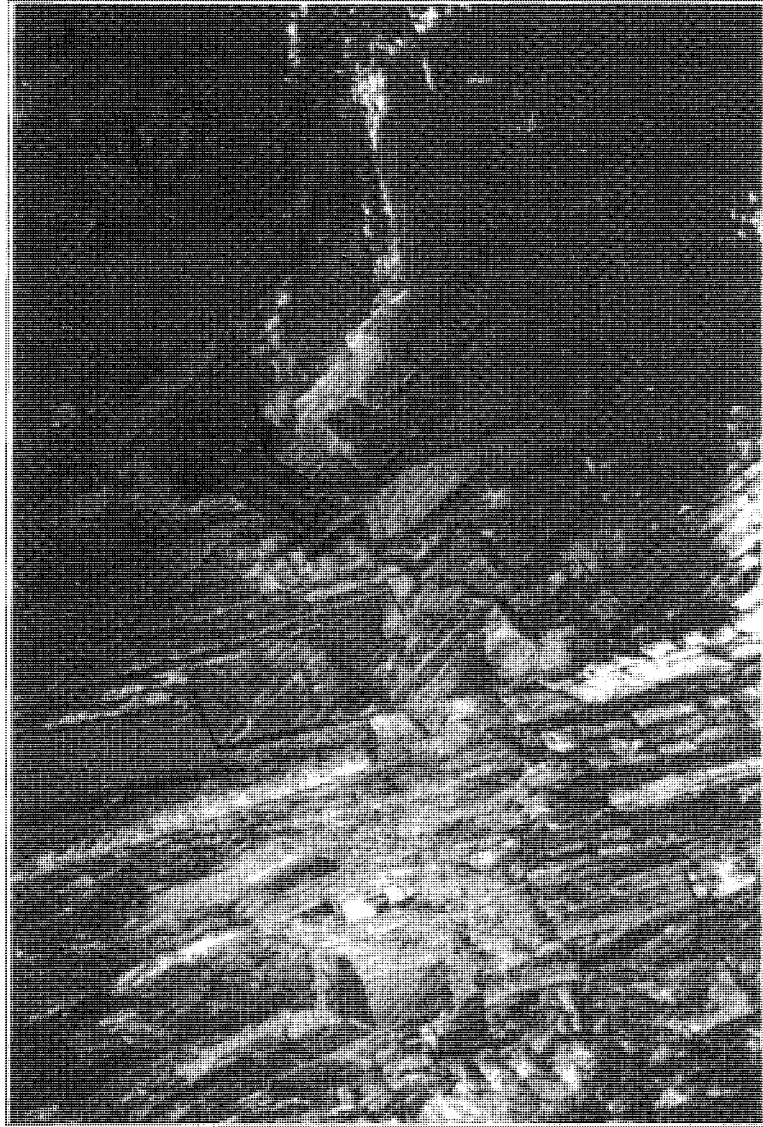
PLATE 83

Ch. 4500 Tunnel intersects major fault. Roof will require rock bolting with mesh and gunite

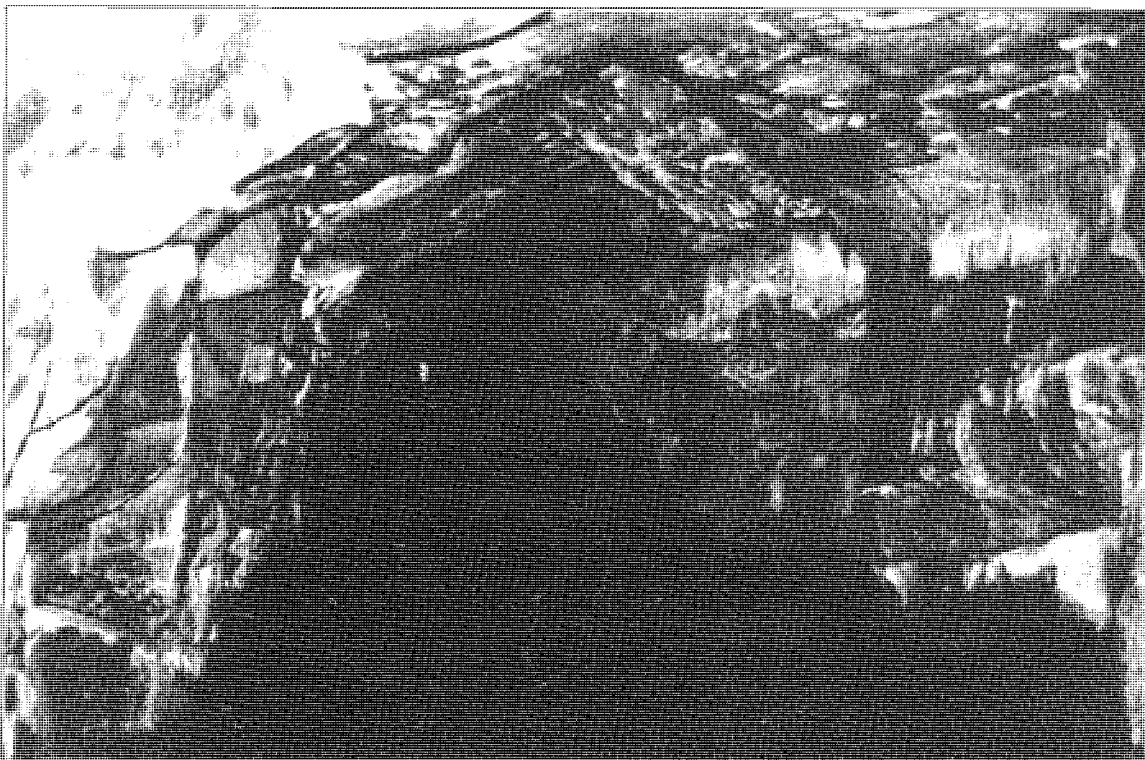
PLATE 84

Ch. 4656 – Ch. 4827 Shale grits. Large blocky structure. Rock bolting pattern for public navigation.

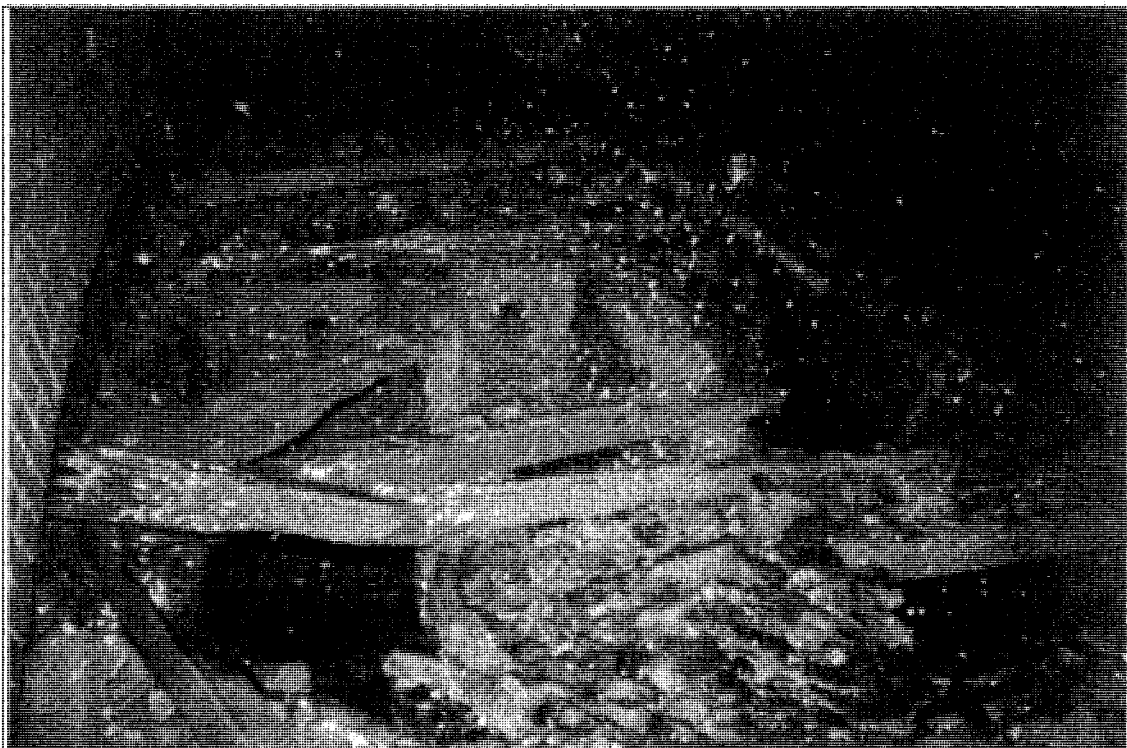
PLATE 41
Base structure, Pule Ventilation Shaft, 141m below ground level.

Although all the ventilation shafts were videoed for their full depth, the primary concern was the base structure over the canal tunnel. It is recommended that all six base structures are replaced and suitable alternative structures have been outlined and included in this Report. For completeness a cost has been included in the report for repairing the ventilation shafts.

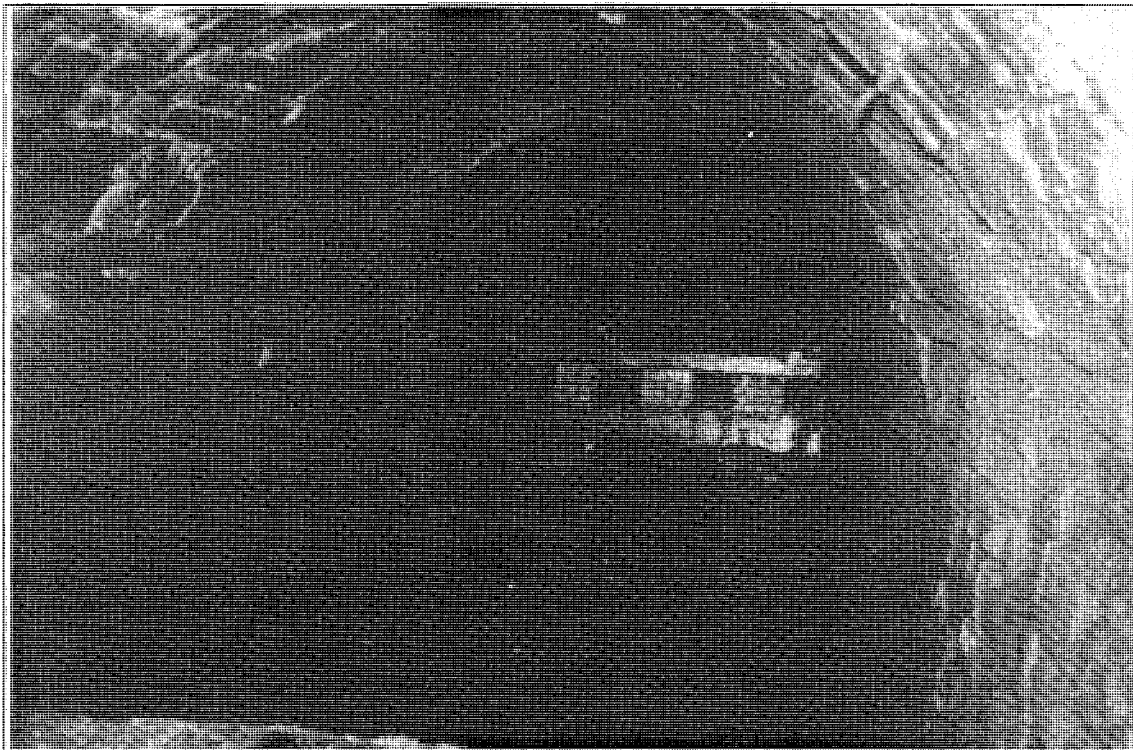
Cote Pit Ventilation Shaft. Base structure 67m below ground level.

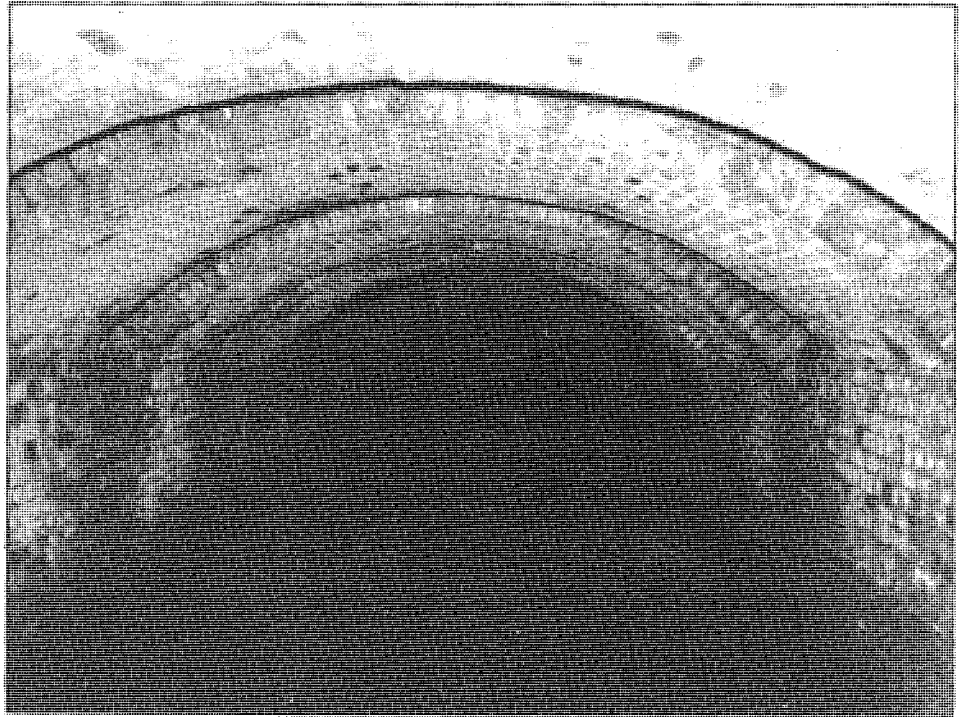
A typical example of intermediate brick arches. These are segmental where the canal width is wider than usual.

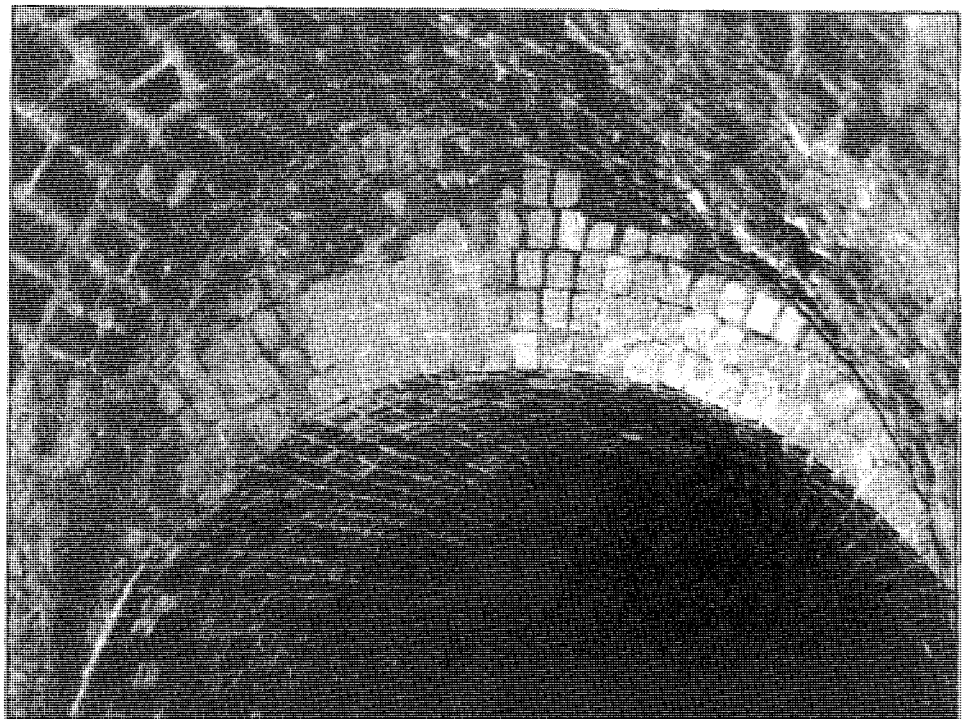
Example of a change of construction from stonework to brickwork. Note the extent of the oily soot encrusted on the walls and roof.

The majority of the stonework was found to be in a stable condition. The main concern is the thick sooty deposit (inherited from the days of steam locomotives) which is now encrusted on the tunnel profile throughout its length. These

sooty deposits are of a high acidic nature and have been attacking the lime mortar over many years. This has caused the mortar at the surface of the stonework to "boil", becoming friable and falling out of the joints, particularly at the crown of the arches.

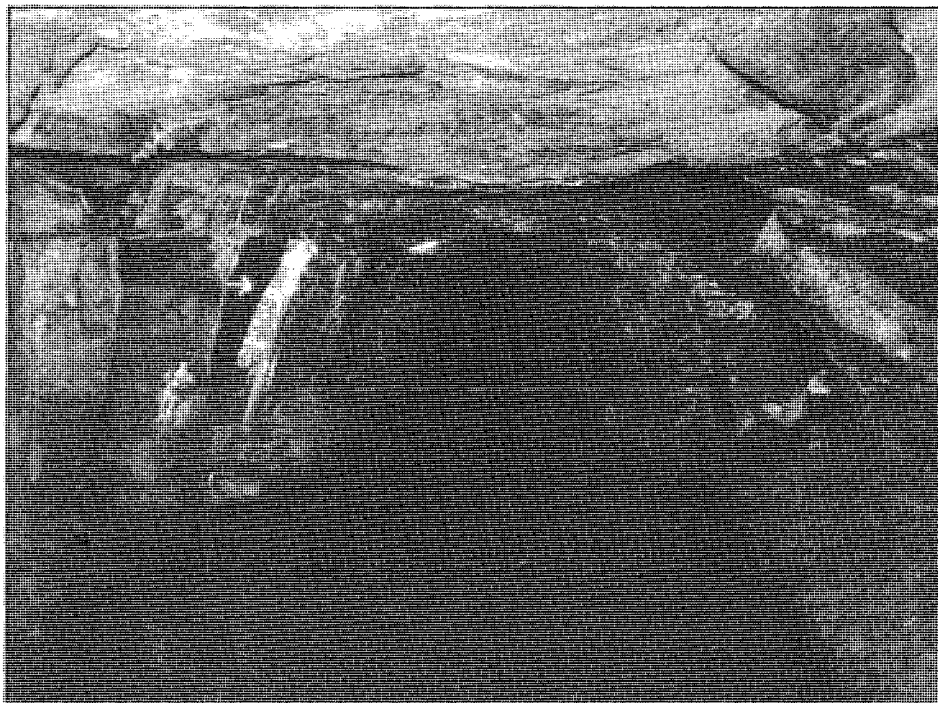
Section of unstable rock. The white arrow on the left indicates a loose slab

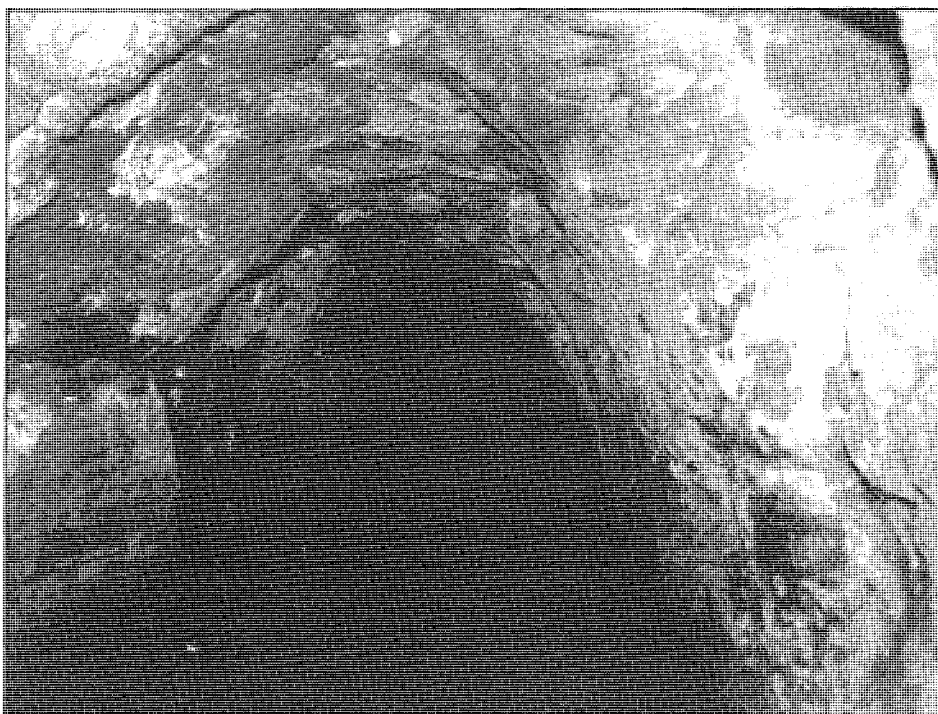
Typical example of exposed rock tunnel which has remained unsupported since the tunnel was constructed. Monitoring is recommended however to ensure future degradation is checked.

Exposed rock areas where support is not presently required will still need to be regularly checked for signs of instability. It is recommended that certain areas need to be monitored using simple "tell-tale" gauges so that the potential for collapse can be periodically assessed. The need to carry out any future support work can be through a controlled programme rather than as an urgent expediency resulting from an unforeseen occurrence.

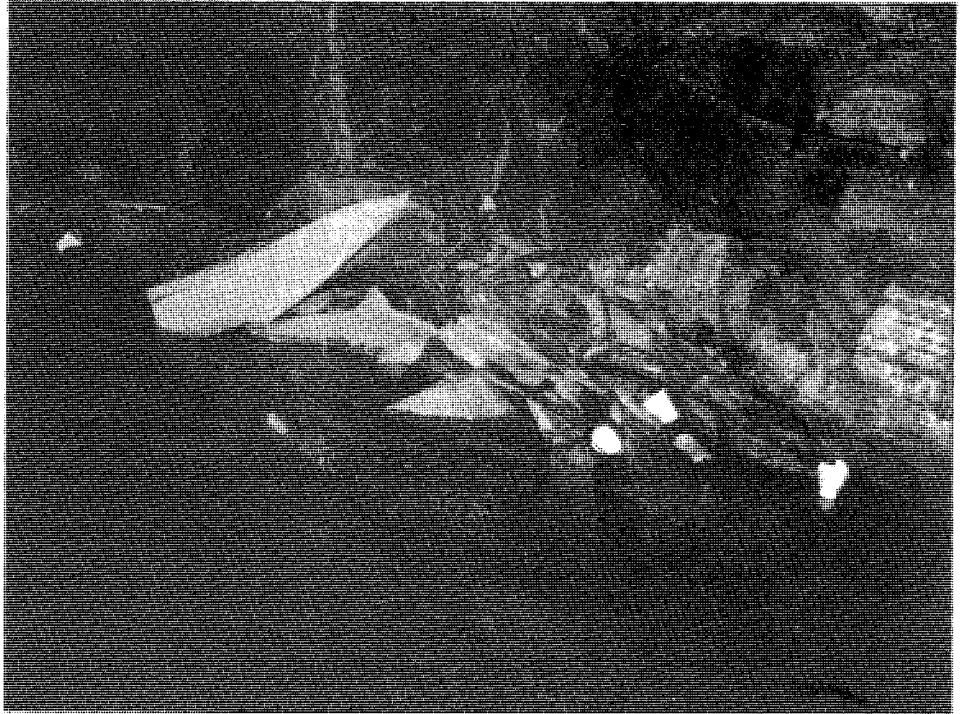
Rock fall from the tunnel side walls evident in unstable areas.

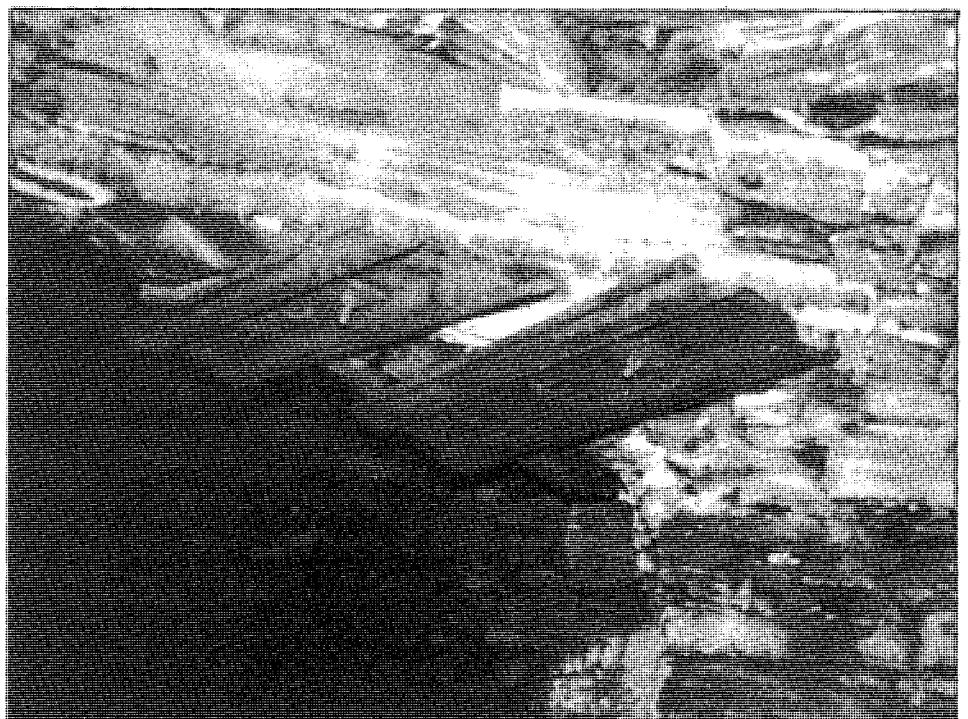
Efforts to arrest the rock spalling from the roof can be seen at the location of a major fault.

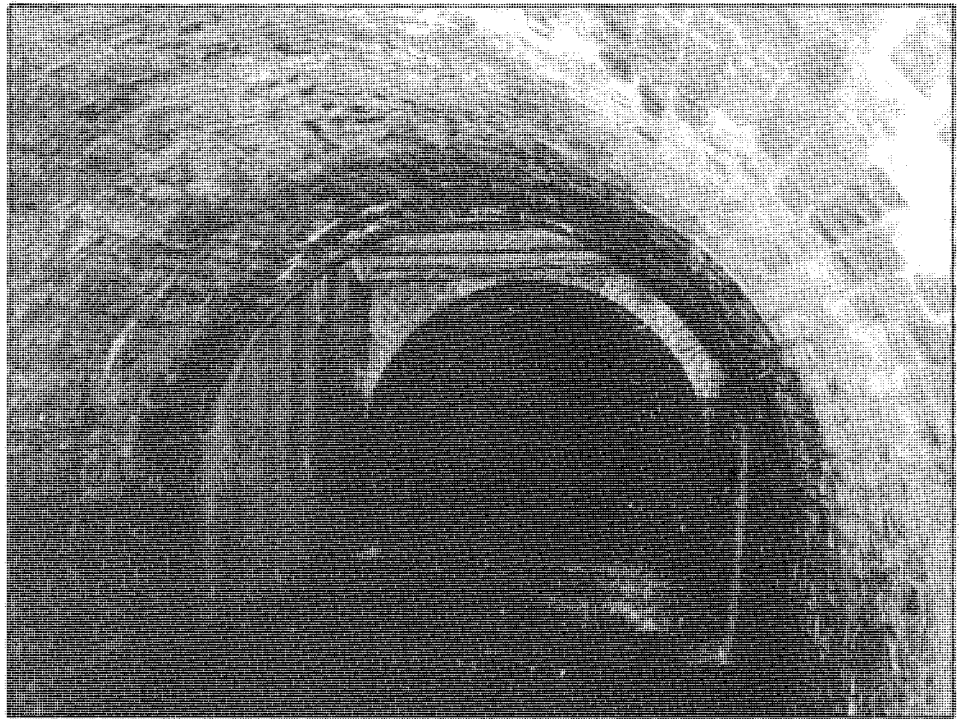
Pule ventilation shaft. The base structure is totally decayed and water is freely pouring down into the canal.

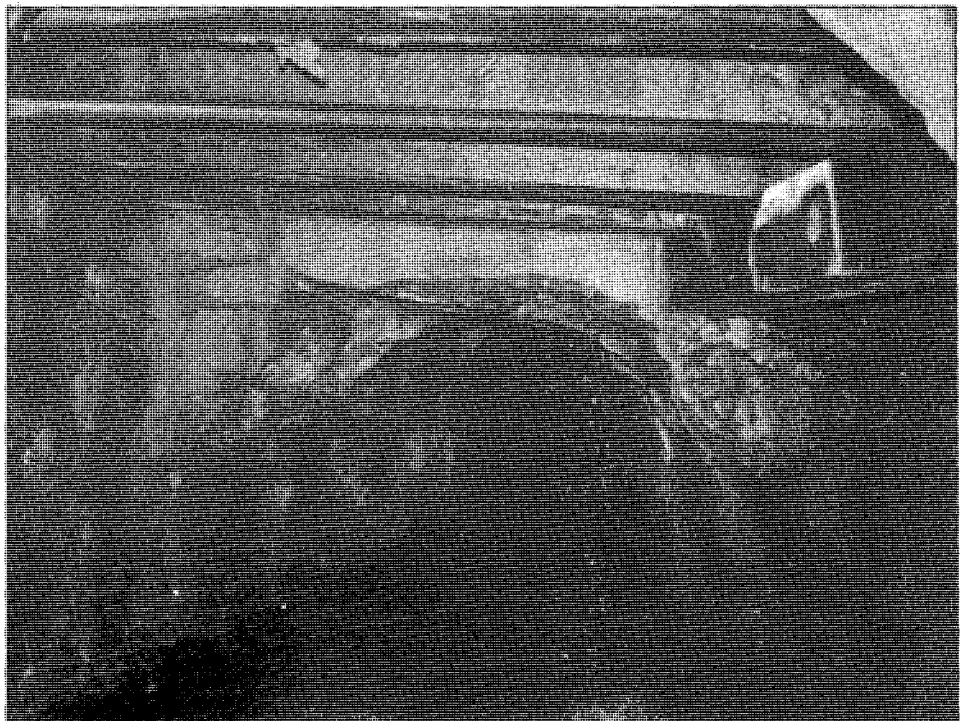
Flint old ventilation shaft. The water downpour has coated the rock wall with iron oxide.

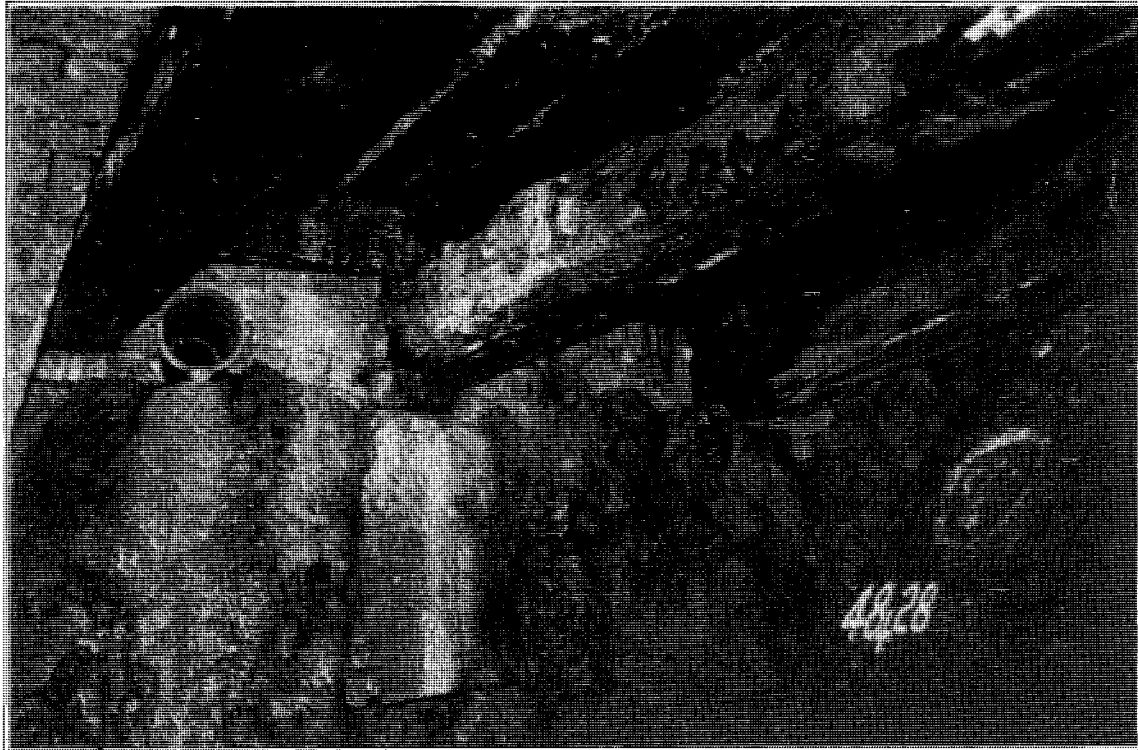
The structural condition of the crossheadings ranges from seriously degraded, and dangerous in some cases (PLATE 33), to apparently sound (PLATE 34).

PLATE 33
A typical crossheading at BR.Ref. 6, Ch. 4629, in a state of serious degradation

Some crossheadings are in a poor state and a replacement bridge structure is required. The majority however can be retained, at least for the foreseeable future, by treatment to the timber decay and improvement to the masonry supports.

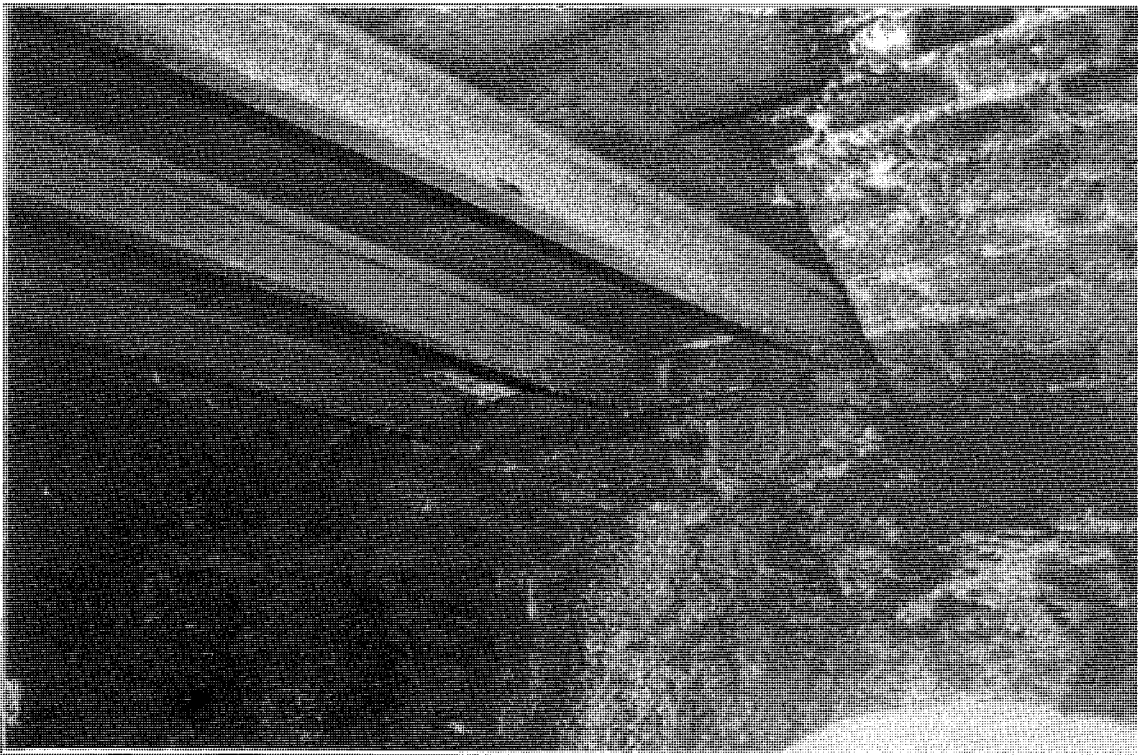
PLATE 38
Crossheading, BR. Ref. 53, Ch. 4106.
Timber decking supported by bullhead rails. Evidence
of degradation in timber and corrosion to steel.

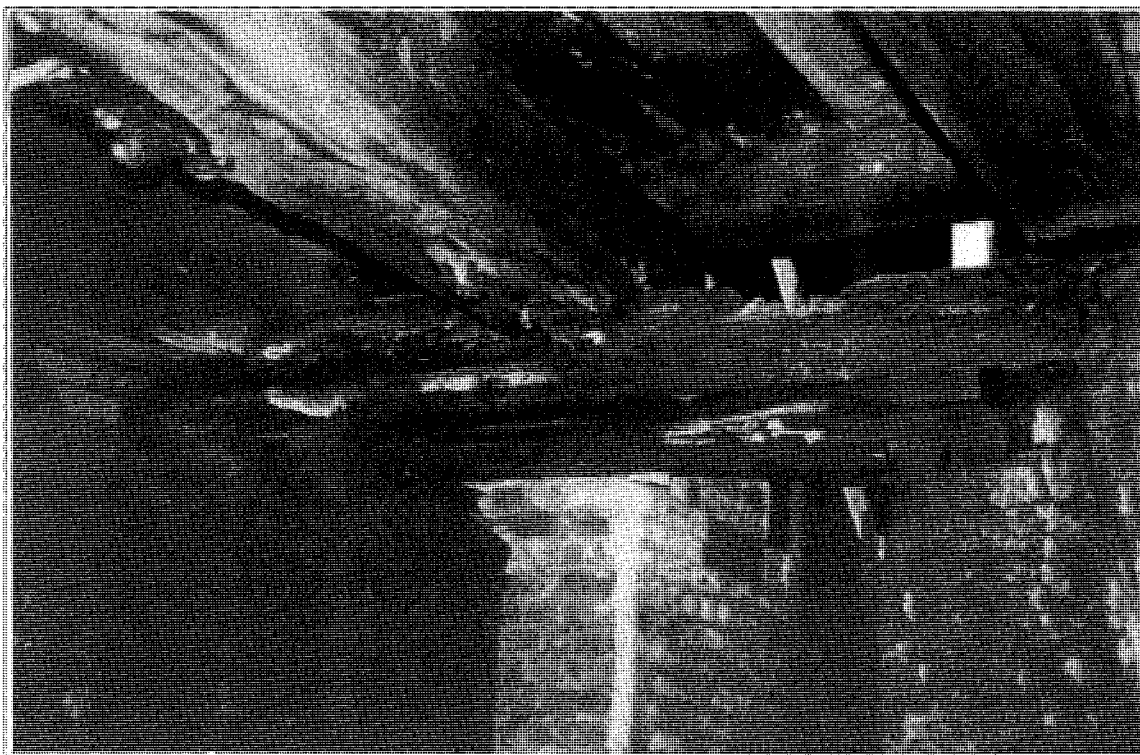
This comprises timber sleepers spanning transversely to the canal, on secondary timber beams, which rest on primary timber beams across the canal. These are supported by brick, rock and timber bearings (PLATE 40). The timber is partially wet and highly degraded and the bearing brickwork is in poor condition (PLATE 33).

PLATE 40
Crossheading, BR Ref. 6, Ch. 4828
Timber beams highly degraded. Bearing brickwork in poor condition

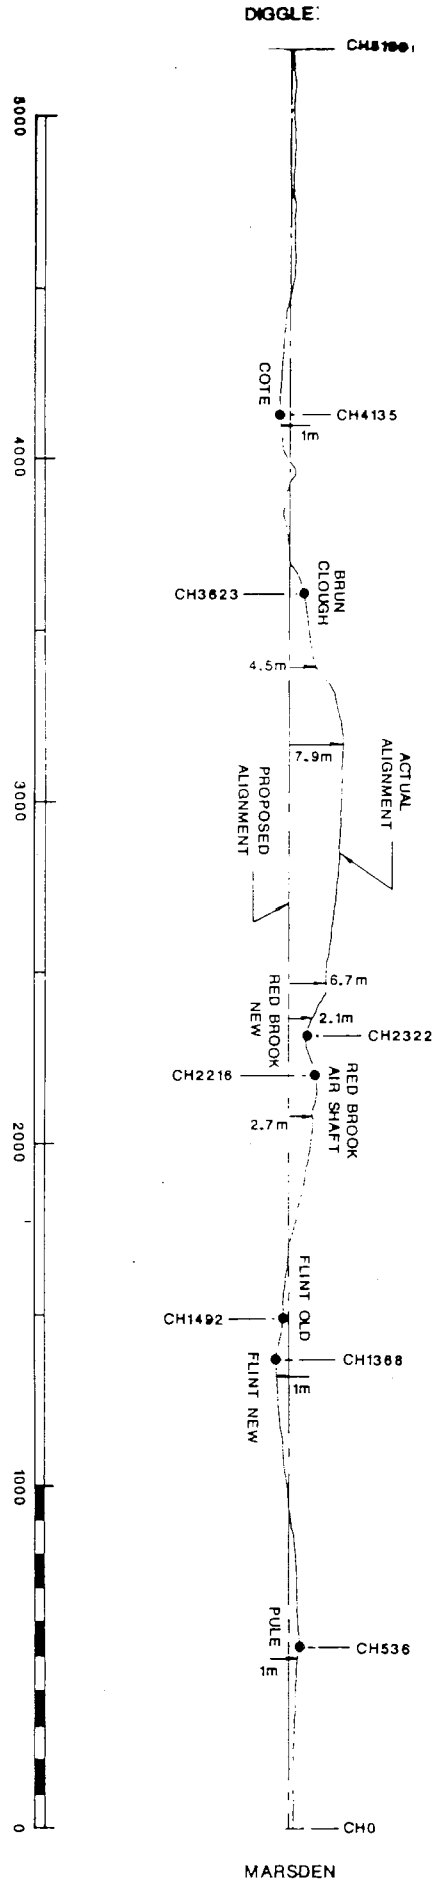
MARSDEN PORTAL.

The portal entrance at Marsden (a listed structure) includes a retaining wall to the overlying fill material. This retaining wall is in a poor condition and requires removal and reconstruction to its original condition with replacement of the fill by a free draining material. The portal at Diggle is in good condition, requiring only minor joint repair.

Marsden portal is the arched stone entrance to the Standedge Tunnel at the Eastern end. This listed structure remains as constructed in 1811, but is now in danger of collapse. The stonework joints are dry and open, and the top section is under pressure from the ground behind it. The top section needs to be dismantled and rebuilt and a free-draining material used to replace the existing soil.

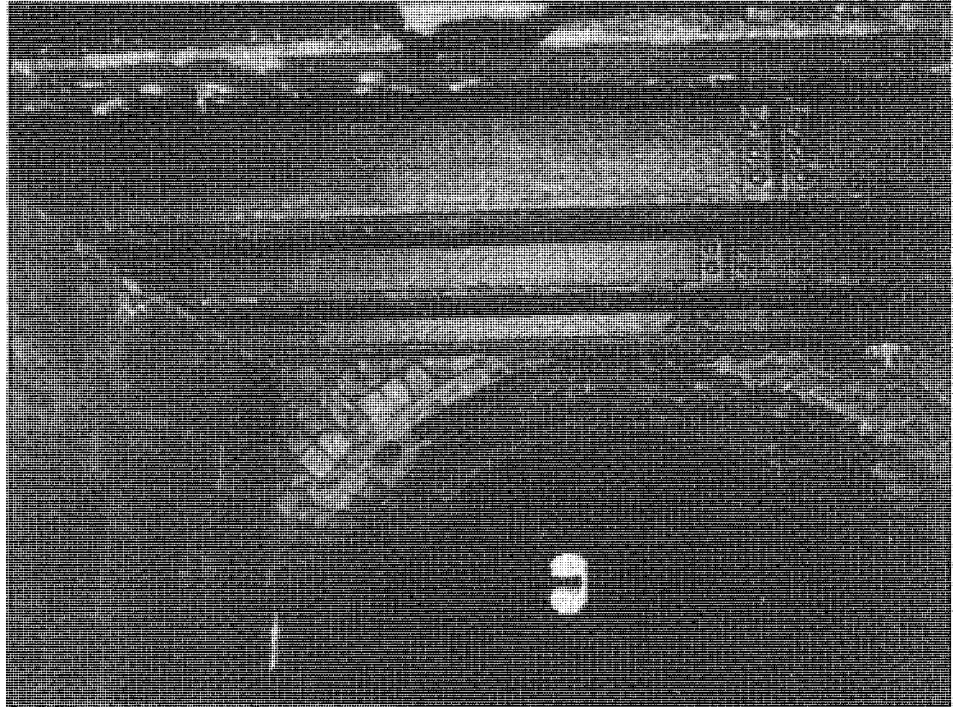
Where the Liverpool and Leeds main railway line crosses the Standedge tunnel at the Diggle end, there is a bridge section constructed in three sections. The steelwork in these sections are suffering from extensive corrosion which needs to be treated before the condition becomes critical. Many of the rivets and bearing plates need to be replaced and all of the steelwork needs sand blasting and painting with a corrosion protection paint.

Large section beams with steel plate decking under the railway extension at Diggle. There is evidence of corrosion in the steelwork that will require treatment.

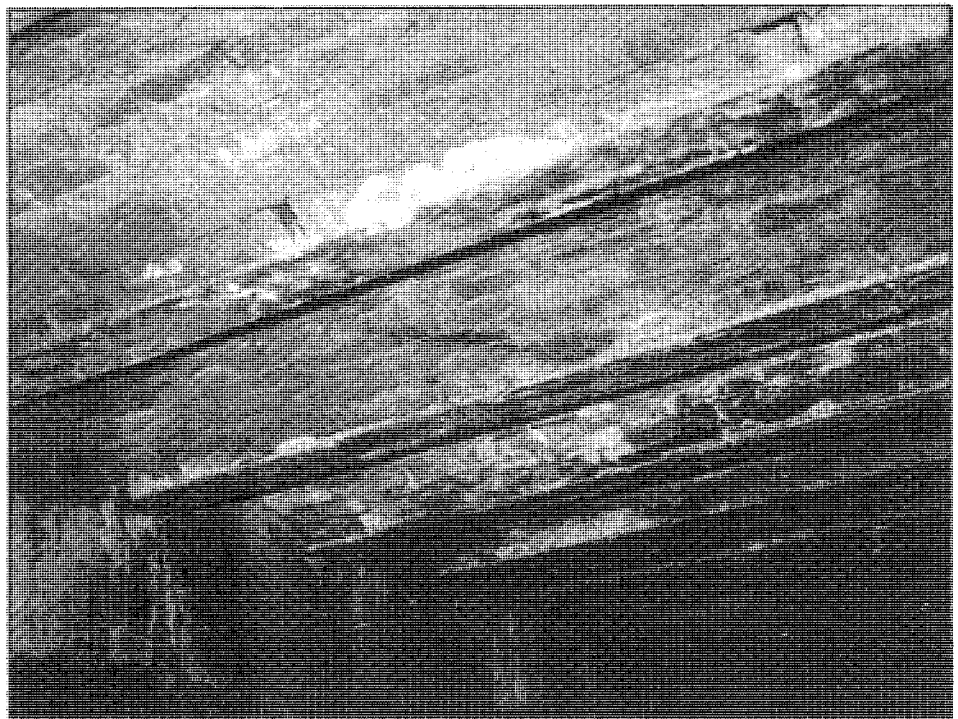
Example of steel beams with brick infill. Note the corrosion to the steel beams that will require treatment.
