**HUDDERSFIELD
CANAL
SOCIETY**

No. 91

TUNNEL SURVEY SPECIAL

Standedge Tunnel Condition Study

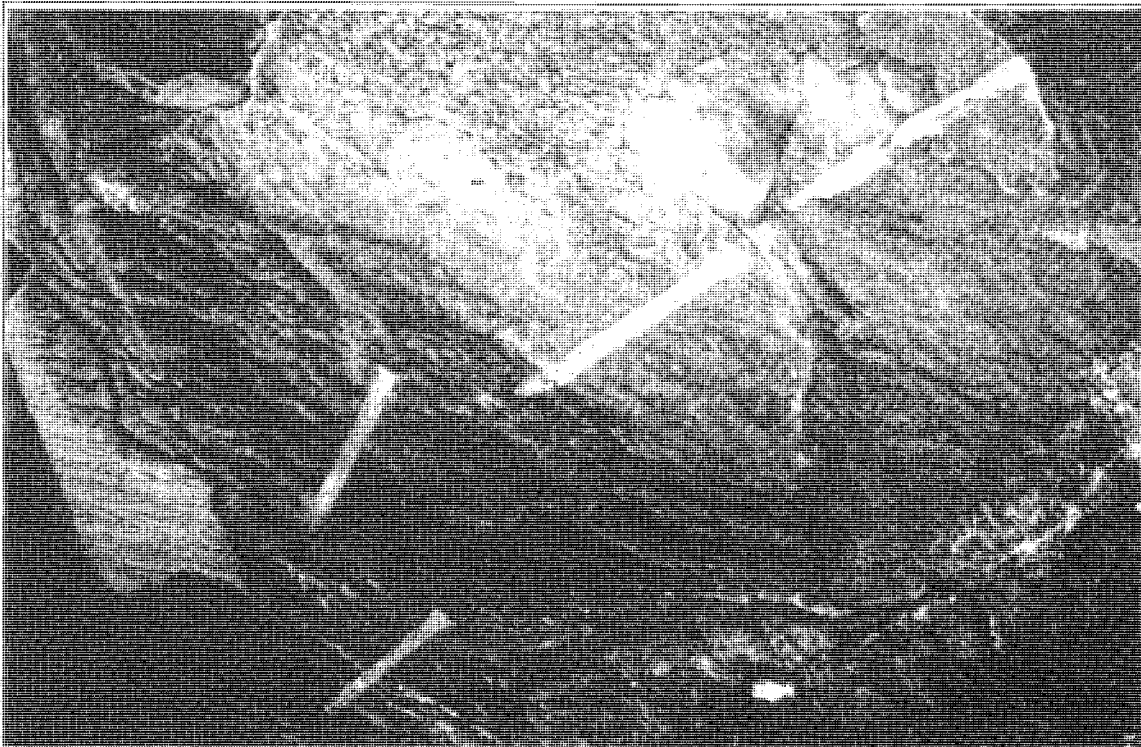
PLATE 1
Evidence of gun powder blast holes used in the construction of the Tunnel.

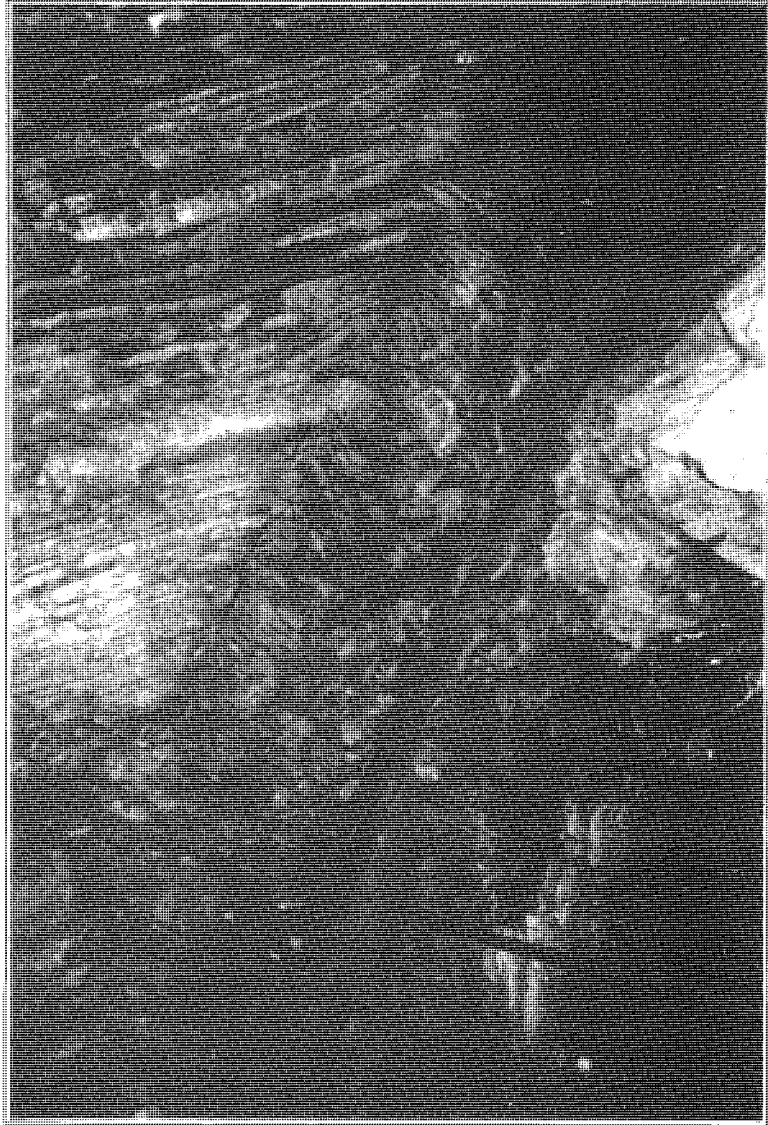
PLATE 58
Fault at chainage 4500

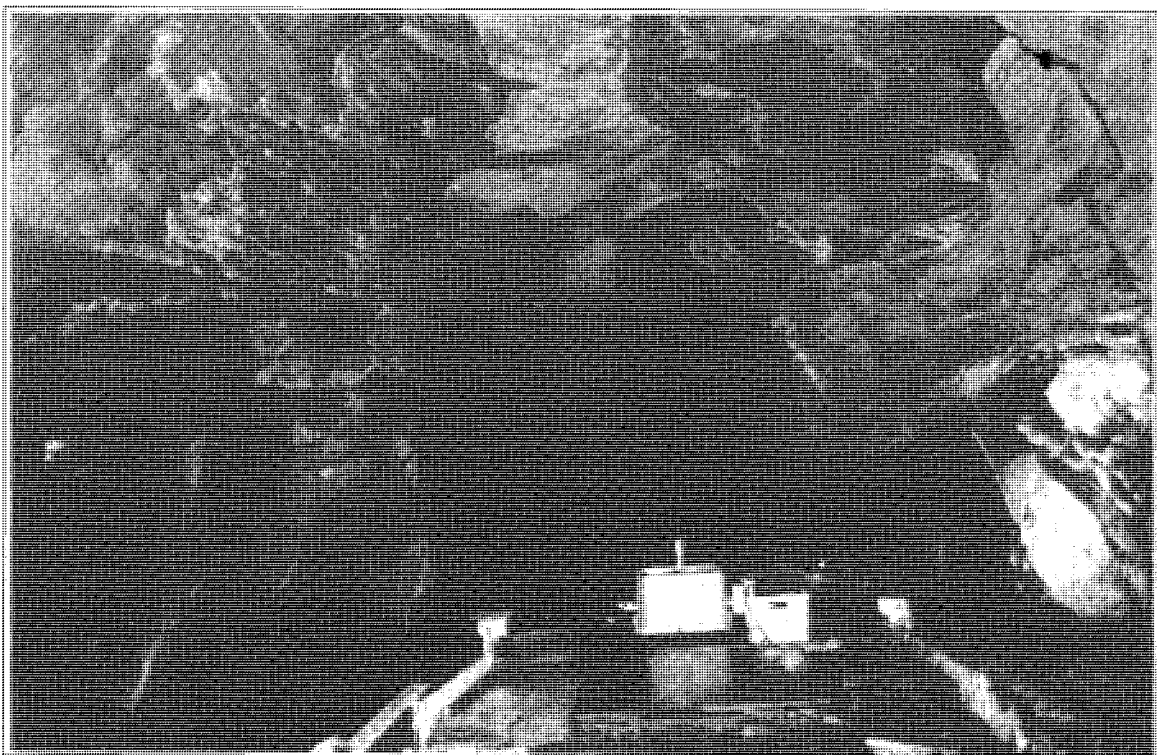
PLATE 64
Kinderscout Grit – bottom part, variable lithology. Interbedded massively bedded and thinly bedded Sandstone.

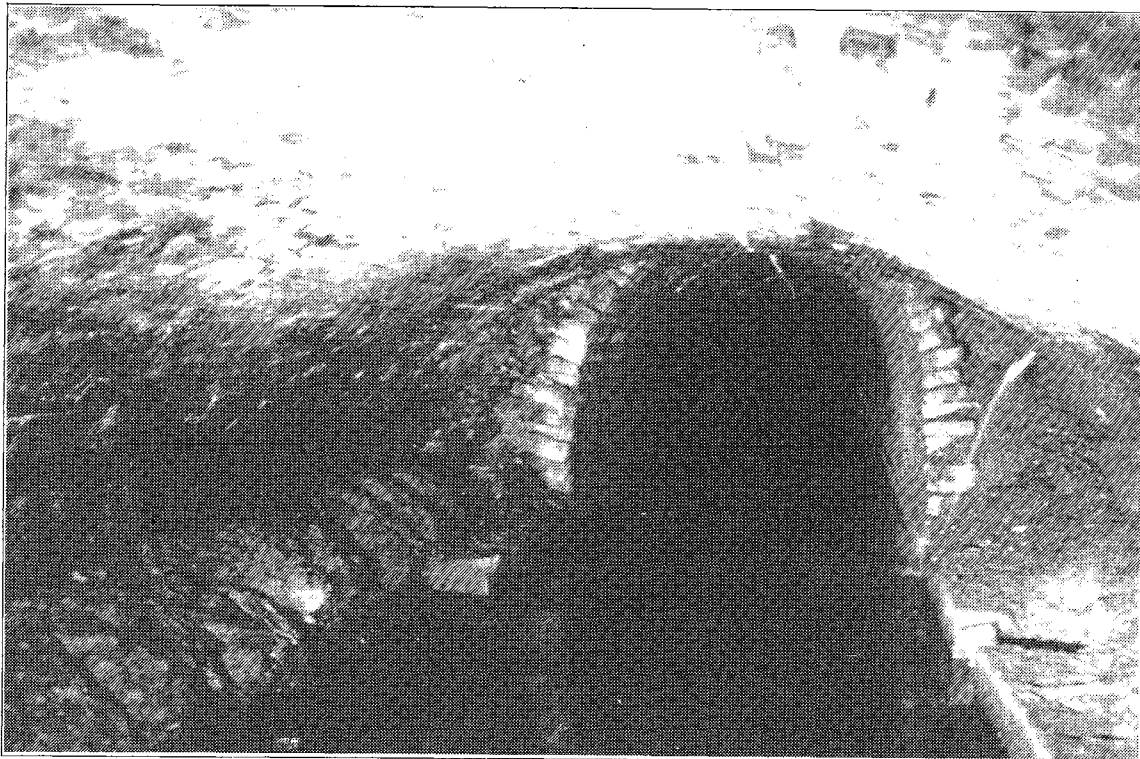
PLATE 67
Middle Grit – basal shaley Mudstone

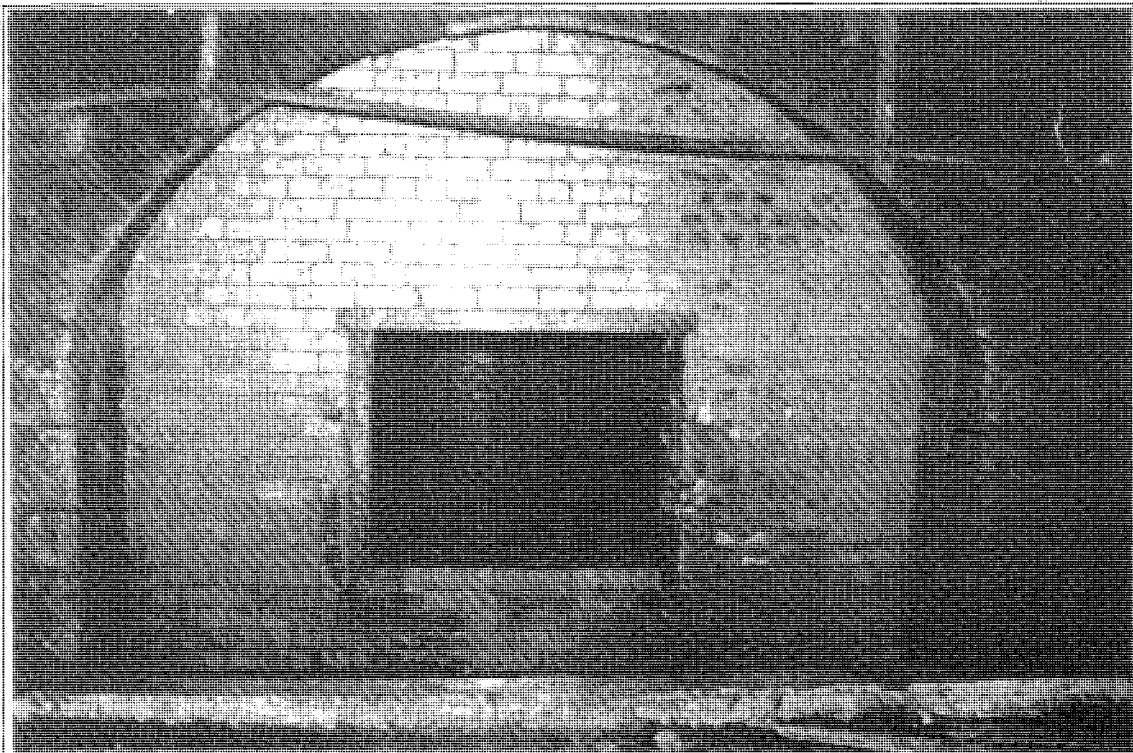
Base Structure for Red Brook Down Cast Ventilation Shaft. 150mm below ground level.
(Note: Shaft does not enter canal).

Although all the ventilation shafts were videoed for their full depth, the primary concern was the base structure over the canal tunnel. It is recommended that all six base structures are replaced and suitable alternative structures have been outlined and included in this Report. For completeness a cost has been included in the report for repairing the ventilation shafts.

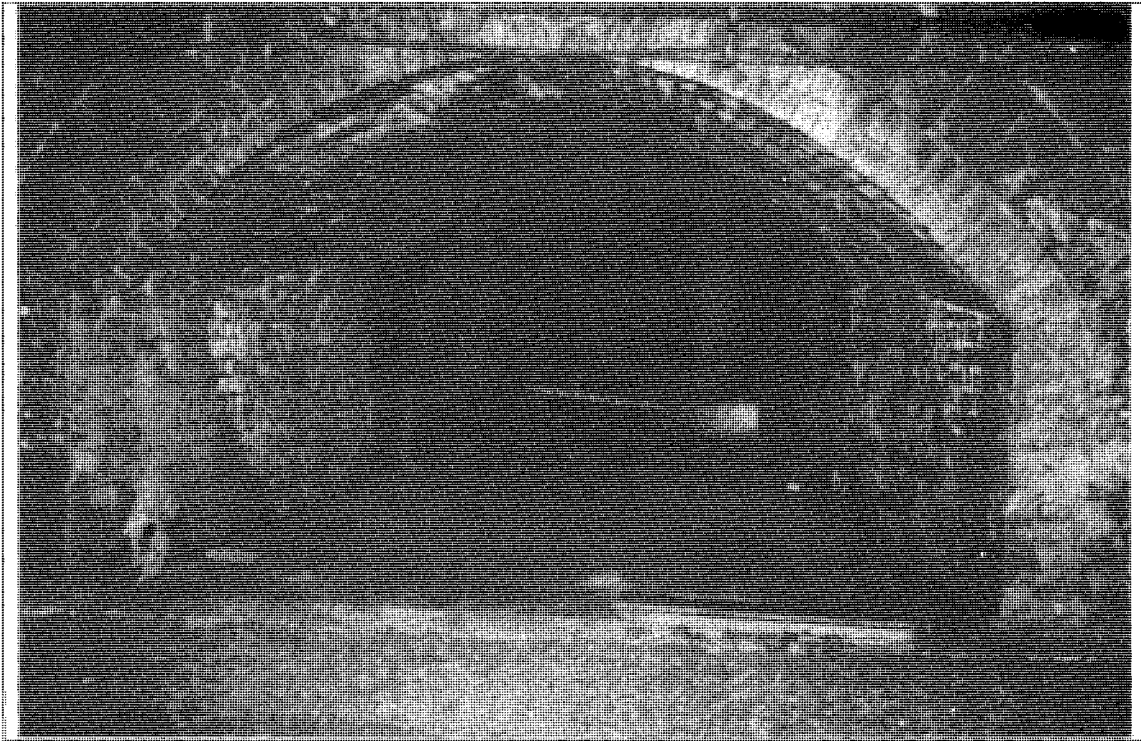
PLATE 8
Pule Ventilation Shaft, BR. Ref. 289, Ch. 536
Figure 19449/AC/3 Appendix Volume 2
Photograph taken from disused Northern Rail Tunnel.

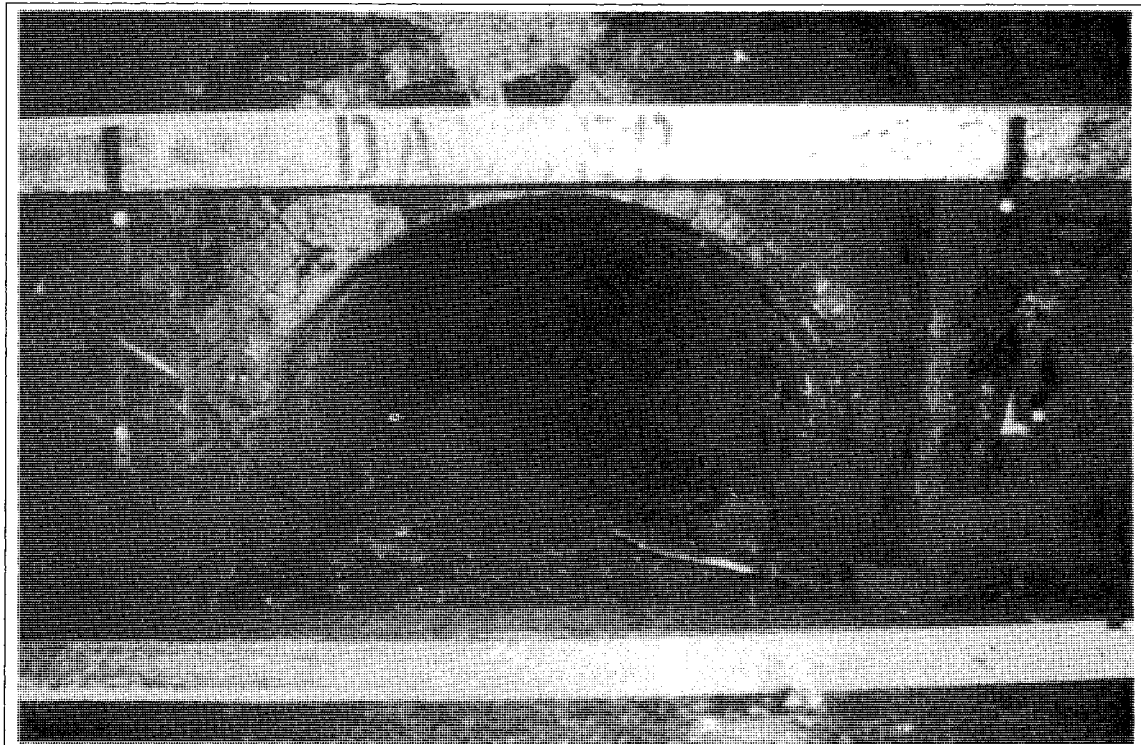
PLATE 9
Adit to Canal, BR. Ref. 287, Ch. 563, Figure 19449/AC/4
Appendix Volume 2
Photograph taken from disused Northern Rail Tunnel

The masonry lined adits do not pose a threat to the water flow but are deemed necessary for maintenance access. The remedial works which should ultimately be undertaken are joint repair and eventual jet hosing of the surfaces to remove the soot deposits for joint protection. The unlined adits require a lining at the canal interface to prevent deterioration of the rock.

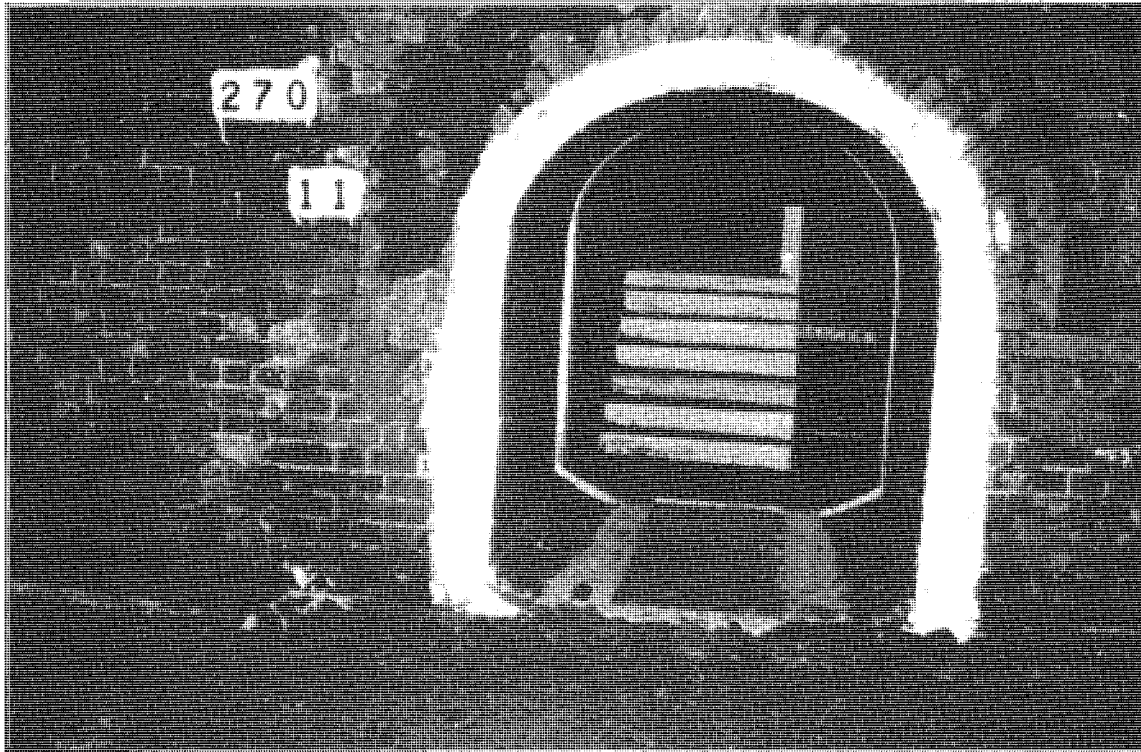
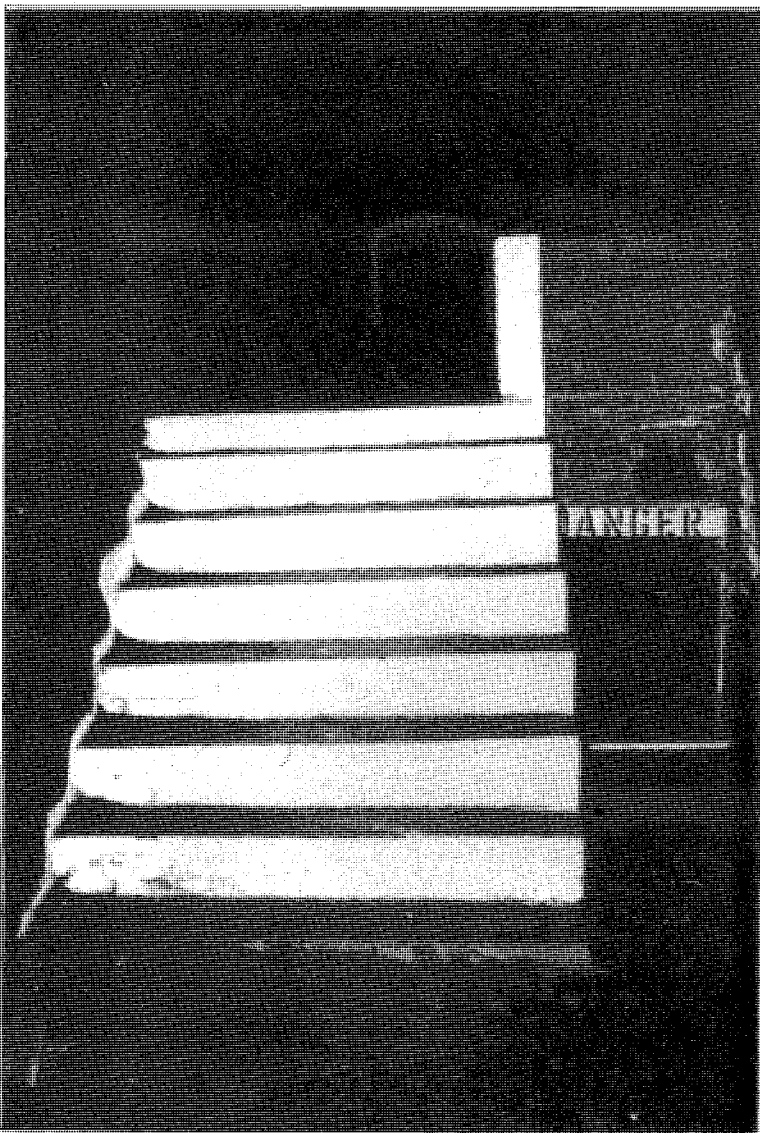
PLATE 10
Crossheading BR Ref. 270, Ch. 821.
Figure 19449/AG/5, Appendix Vol. 2
Photograph taken from disused Rail
Tunnel.

View of Crossheading.
Note Canal access to right-hand side.

Certain of the crossheading bridge structures over the canal pose a threat to the canal as their total collapse into the water could create a dam. The condition of the fourteen crossheadings is such that it is recommended that some 4 No. are replaced as soon as possible due to poor support foundations and decking, whilst the remainder are maintained with a view to future replacement.

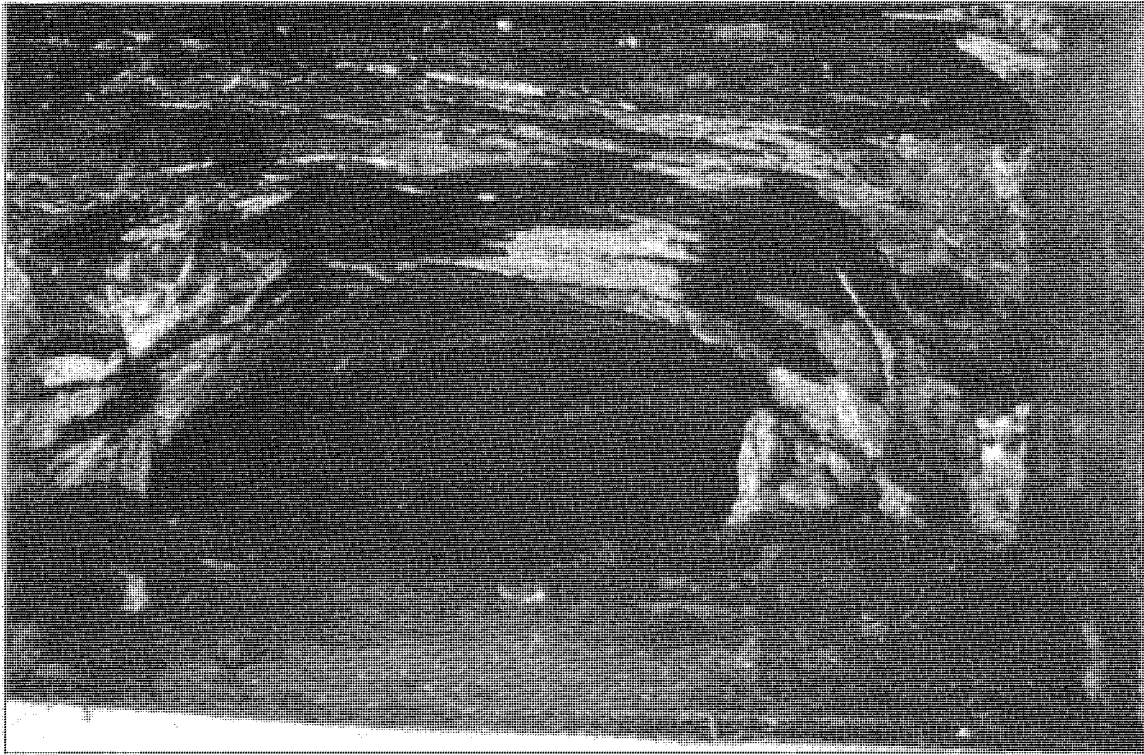
PLATE 20
Adit to Canal. BR Ref. 135/6, Ch. 2863 Figure 19449/AC/15
Appendix Volume 2.
Photograph taken from disused Northern Rail Tunnel

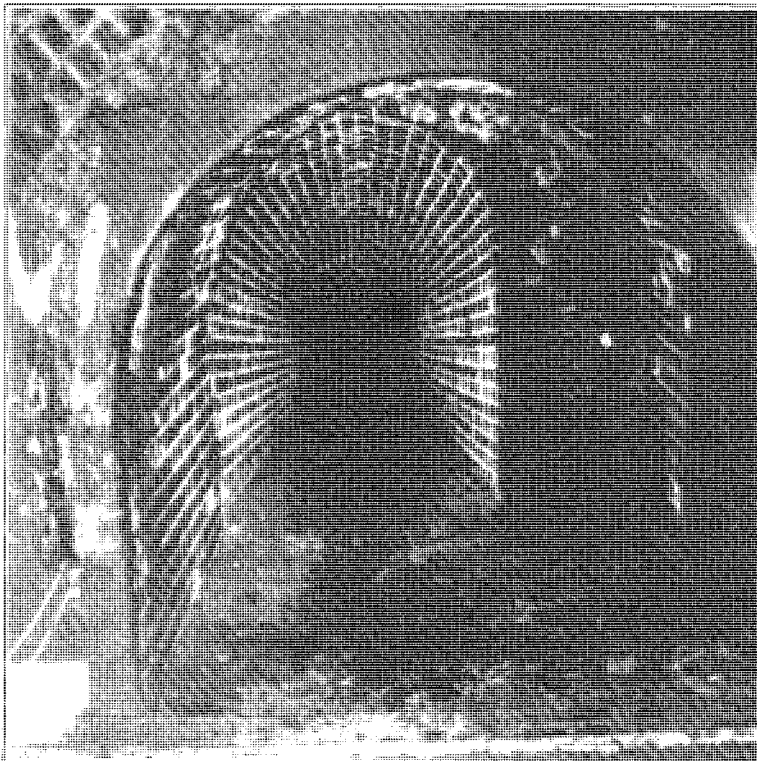
PLATE 23
Adit to Canal. BR Ref. 87, Ch. 3599. Figure 19449/AC/18,
Appendix Volume 2.
Photograph taken from disused Northern Rail Tunnel.

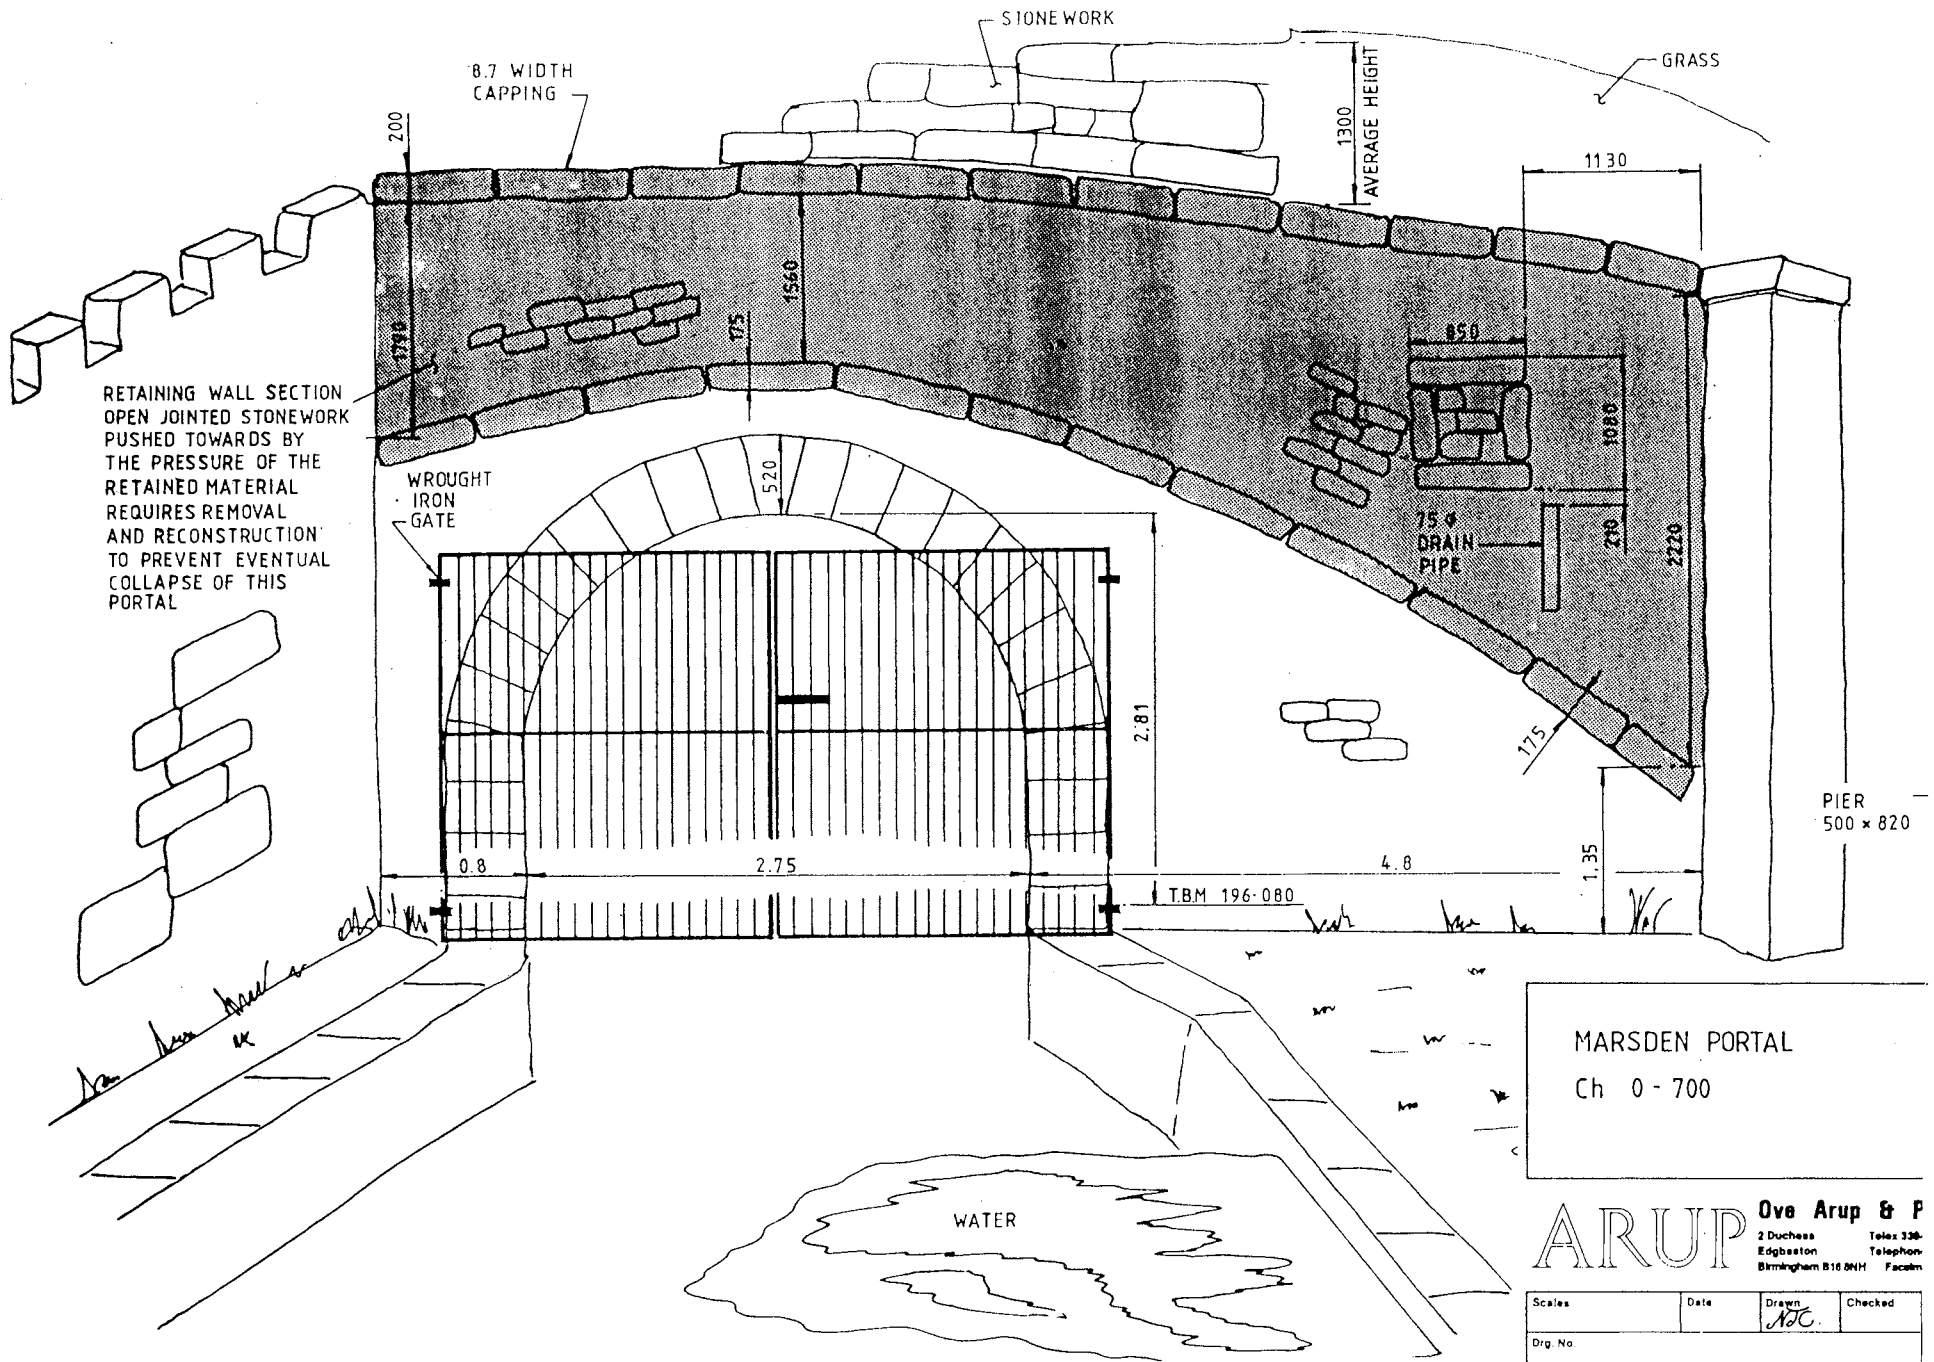
FIGURE 33

MARSDEN PORTAL
Ch 0 - 700

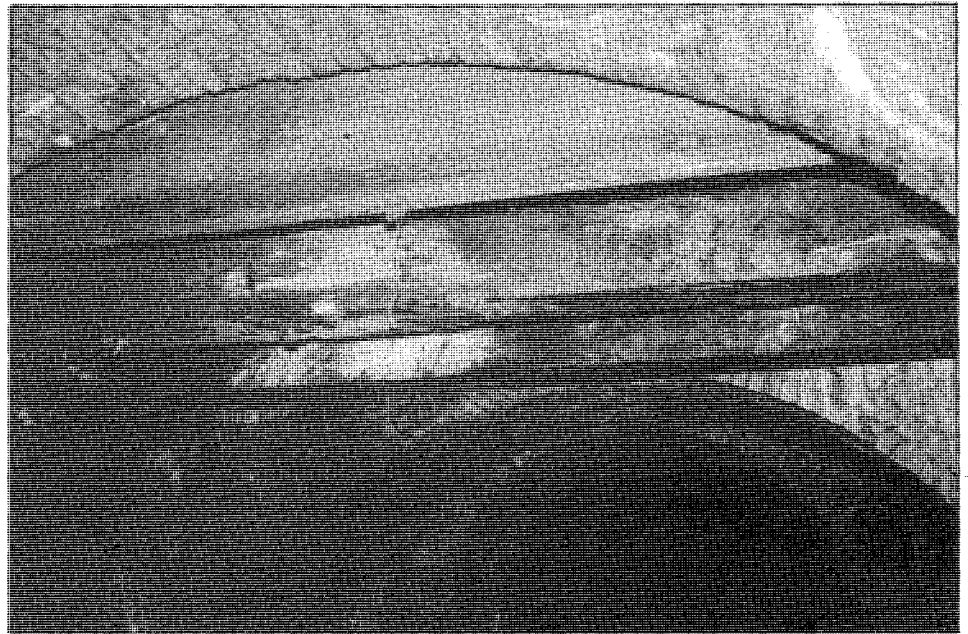
Crossheadings with canal access chainage 4830 (BR. REF 6).

Some crossheadings are in a poor state and a replacement bridge structure is required. The majority however can be retained, at least for the foreseeable future, by treatment to the timber decay and improvement to the masonry supports.

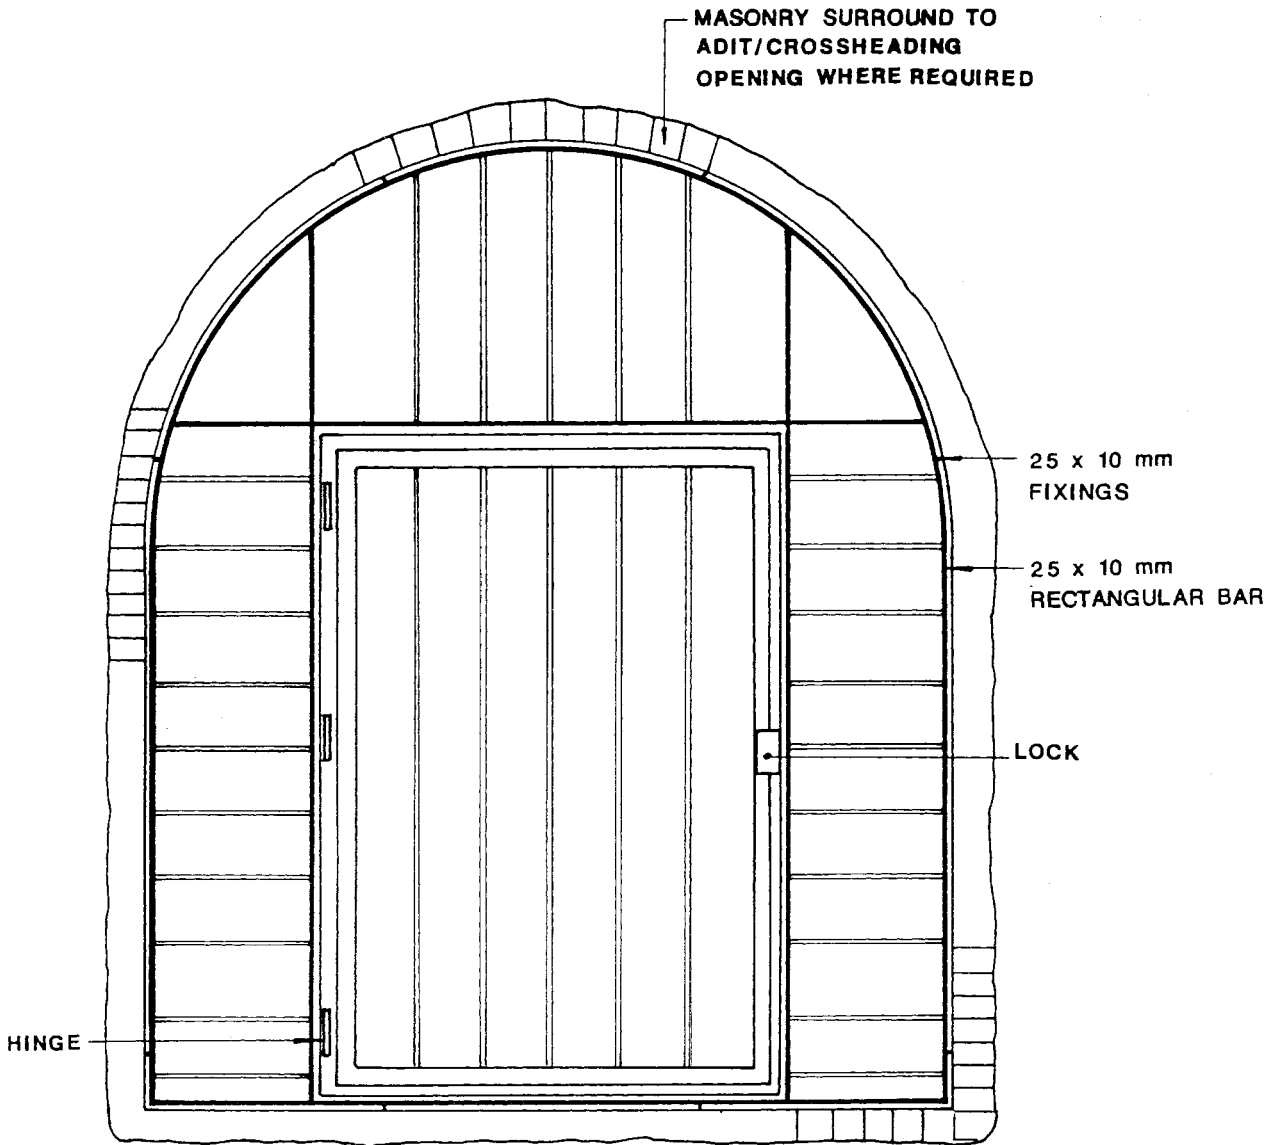
TYPICAL DETAIL SHOWING LOCKABLE GRILLE FOR ADITS AND CROSSHEADINGS WITH CANAL ACCESS

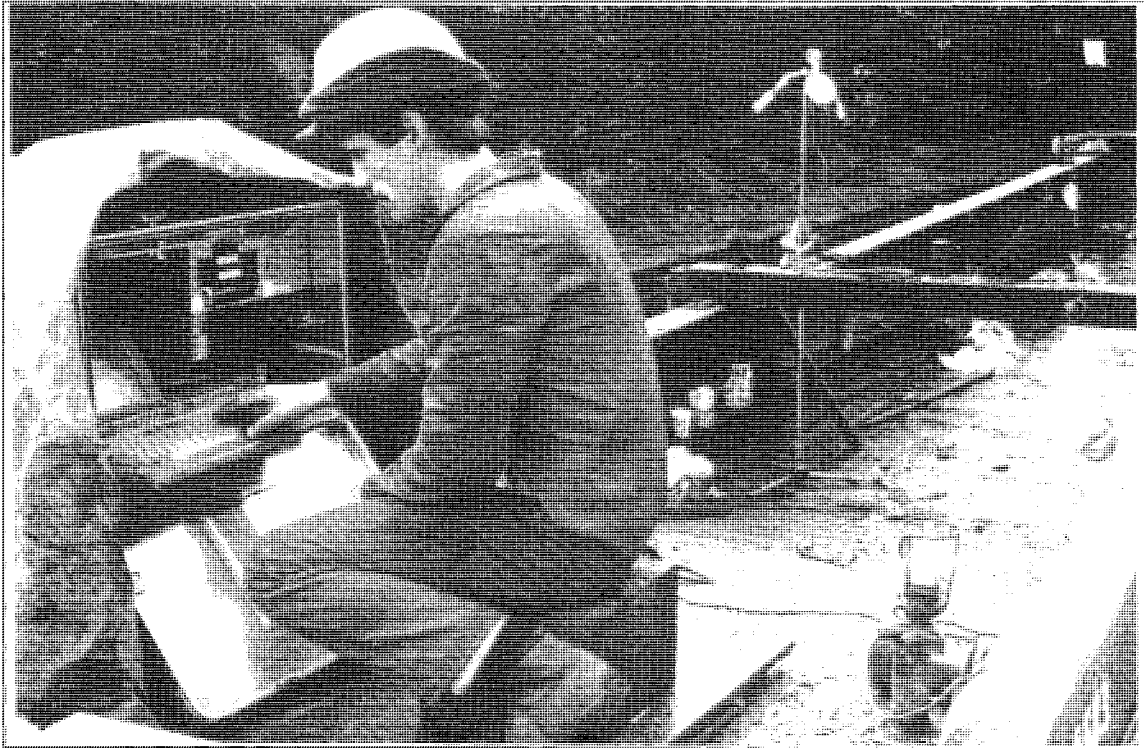
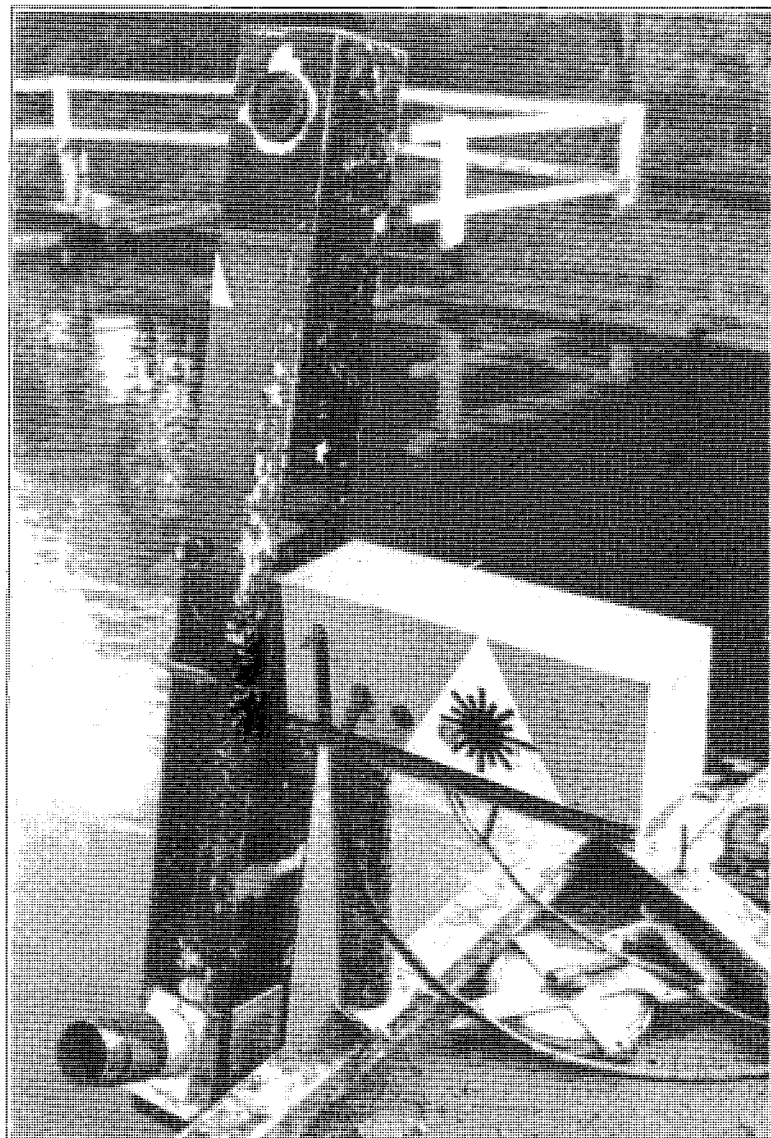
PLATE 28
Views of laser profiling equipment
and computer recording instrumen-
tation mounted on converted
British Waterways boat.

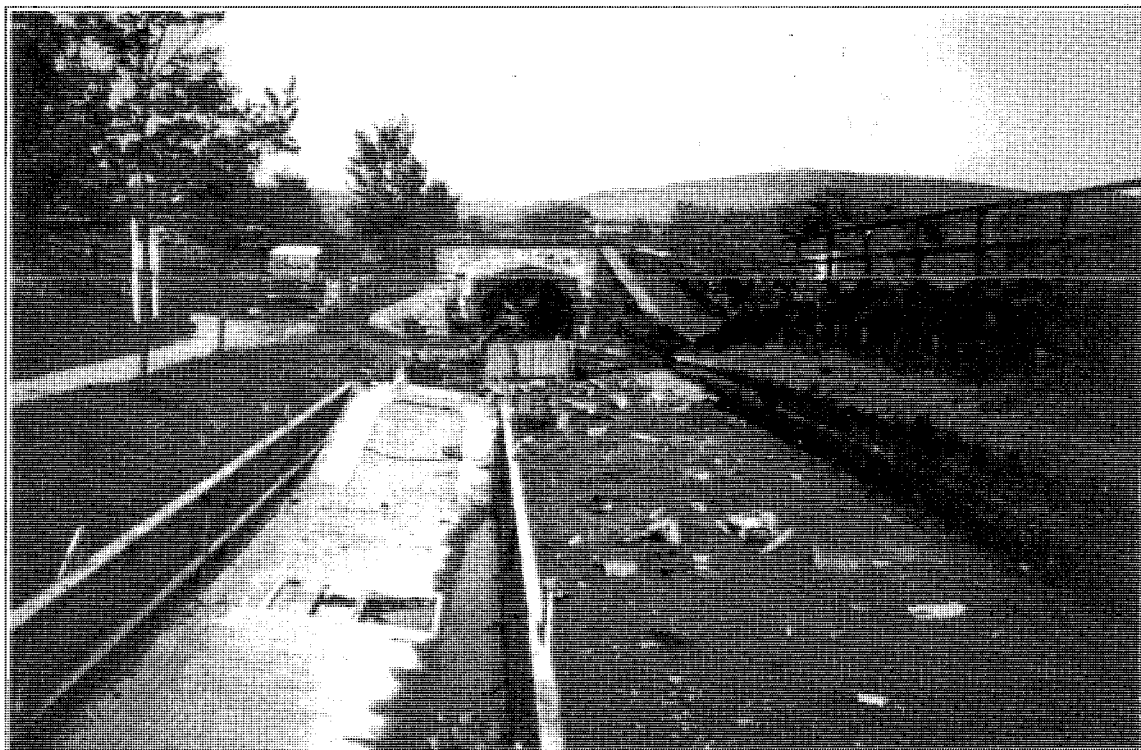
PLATE 29
Diggle Portal and Canal Basin after de-watering had taken place
